CRITICAL UPDATE

Firmware Patch for Crucial M4 Solid State Drives (SSD) in One-Net's Shipped Between August 14, 2011 to April 20, 2012

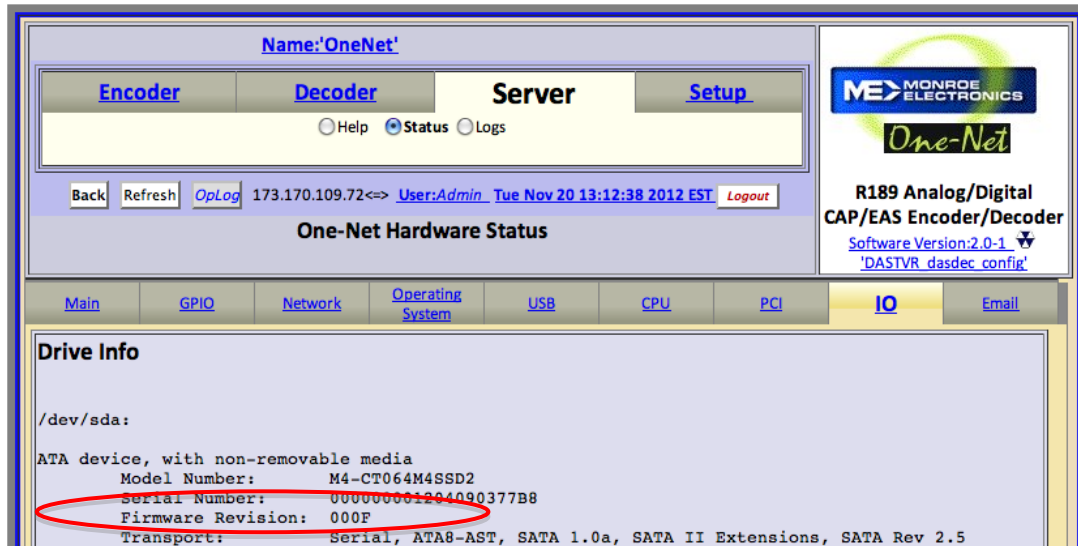
Figure 1 Drive Info page available with Version 2.0-0_a05 and above

If the Firmware Revision is **000F** (shown above) or **higher**¹ no further action is necessary. Otherwise proceed to **Firmware Update Procedures** below.

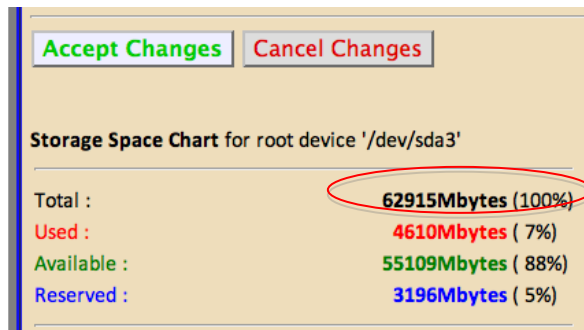
If the **Total:** line displays a number of **62xxxMbytes (64GB)** then the DASDEC has a *Crucial* drive and should be updated.

Figure 2. Alert Storage display indicating *Crucial* 64GB drive installed
